ACAN - ARCHITECTS CLIMATE ACTION NETWORK

Table of Contents

Executive Summary

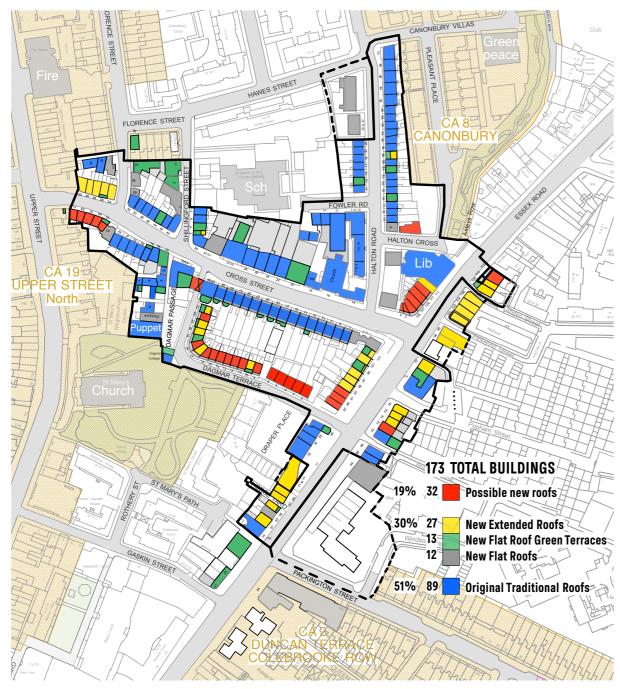
Roof Audit - ACAN worked example London Borough of Islington CA13

Although 7% (13) of the buildings have a full flat green roof terraces as the predominant surface, 22% (38) of all buildings have full or partial flat green roof terraces. This shows there is a contemporary need in a dense urban environment for outdoor space which was not part of the original design of these Georgian and Victorian buildings. Planning today must acknowledge energy requirements and good roof details in visual guidance. There needs to be a new joined up thinking in the planning system between aesthetics/history, and technical/climate details that were not understood 20 years ago.

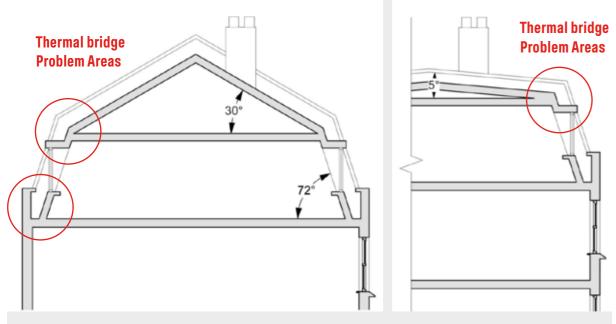
Figure 23 Types of mansard roof extensions. Traditional double pitch mansard roof with dormer windows (left) and flat half mansard roof with dormer windows (right).

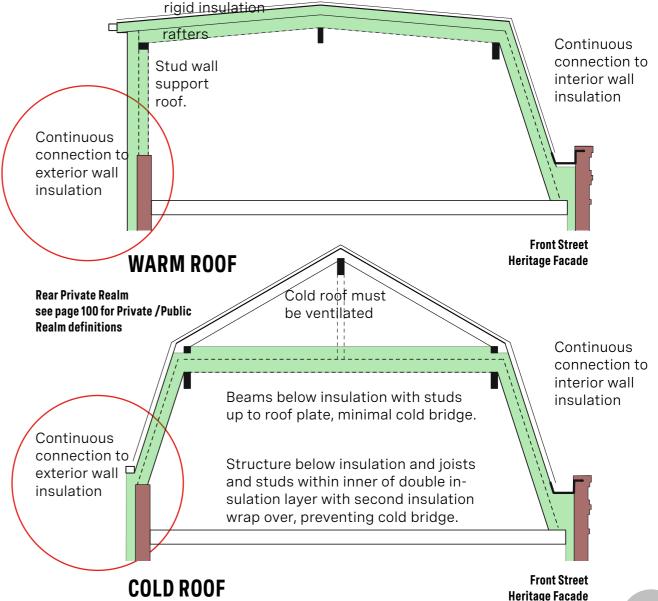
SPD TECHNICAL Warm Roofs

lation wrapped walls and roof with care taken at wall and parapet junctions. LETI recommended 300mm insulation roof minimum if mineral wool is used. Increased height of roof to accommodate 300mm minimum wall/roof insulation overlap to avoid any thermal bridge. Brise soleils required for sunny glazed areas. Cost of retrofit offset by increased living space. **Warm roofs** require 150mm minimum foam insulation panels over the structure to eliminate cold bridges through timber structure. No need to provide ventilation. This can increase internal ceiling height.

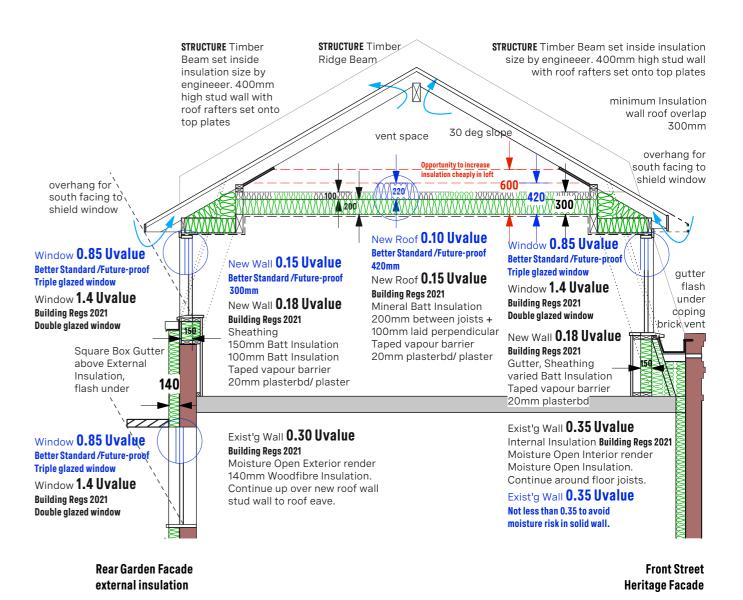
Double Pitch Mansard Roof - Section through Dormers

All U-values are W/m2k

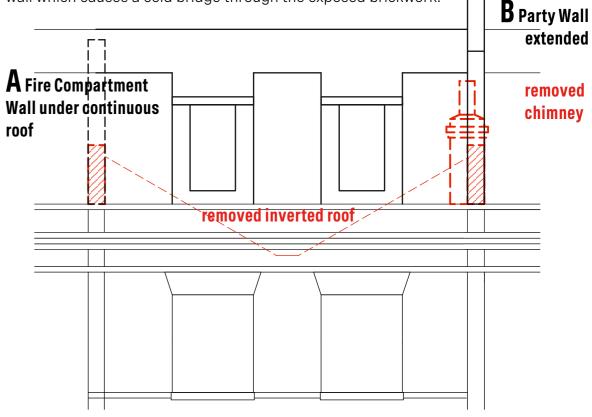
In the example below, the heritage inverted roof was removed along with the chimney in a non listed house. Rebuilding a replica chimney is no longer practical because: the structure below can be missing, it would create a large cold bridge and cause potential damp. Chimneys are now only decorative features as they are not useable.

A new roof extension would be built to highest new construction (Building Regulations or greater) standard which puts a wooly hat over this building. Party walls could be extended or, a fire compartment wall built under a continuous roof spanning multiple terrace houses. The fire compartment wall would be preferable to the party wall which causes a cold bridge through the exposed brickwork.

Where chimneys or roofs have been removed they should not be reinstated

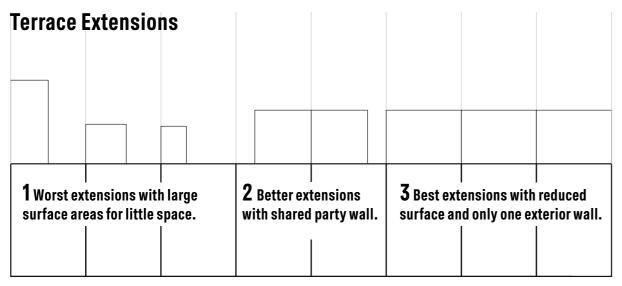
Terrace Houses are very efficient compact forms with shared walls. See the sphere diagram below. Rear extensions need to be carefully considered as they can increase exposed surface area without providing much space. Individual extensions are the worst with 3 walls and roof exposed. Double extensions which share a party wall are better with only 2 exposed walls and roof. Best is a continuous extension with only 1 exposed wall and the roof.

The mid terrace house has a very good Compact Form as the shared party walls remove two surfaces. Rear extensions can decrease or increase the exposed surface area (by infilling or projecting)

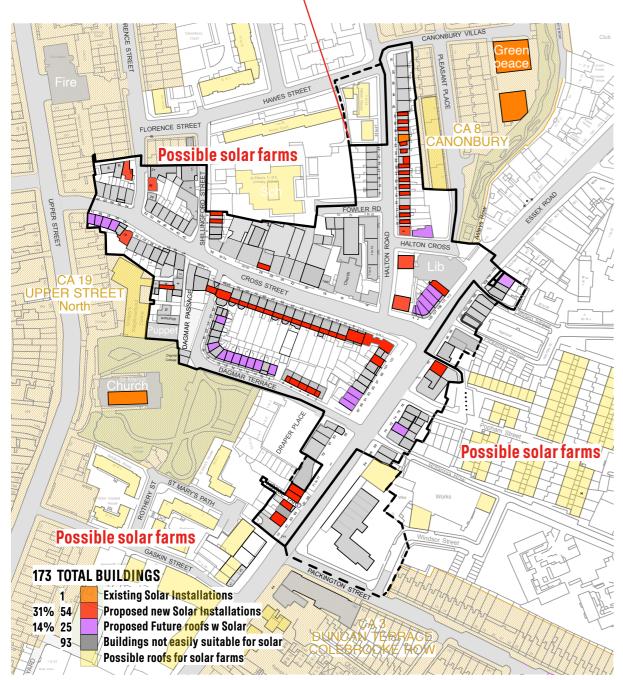
Solar Audit - ACAN worked example London Borough of Islington CA13

31% of roofs are solar suitable

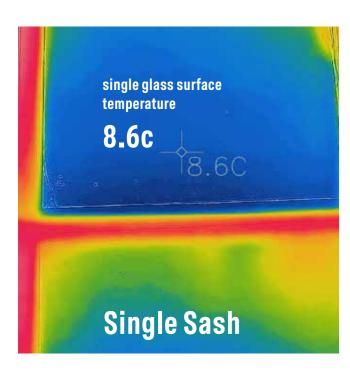
Infrared Camera shows problems with single glazing Winter at 0°C the indoor glass surface was 8.6°C creating drafts. The UK has the worst performing housing in Europe!

Interior Cross Street. Single glazed window with cold surface of 8.6°C, condensation risk. (blue colder)

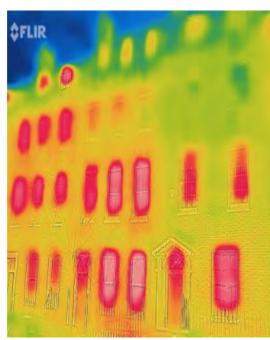
Exterior Cross Street. Single glazed windows with hot surface radiating heat to outside. (red warmer)

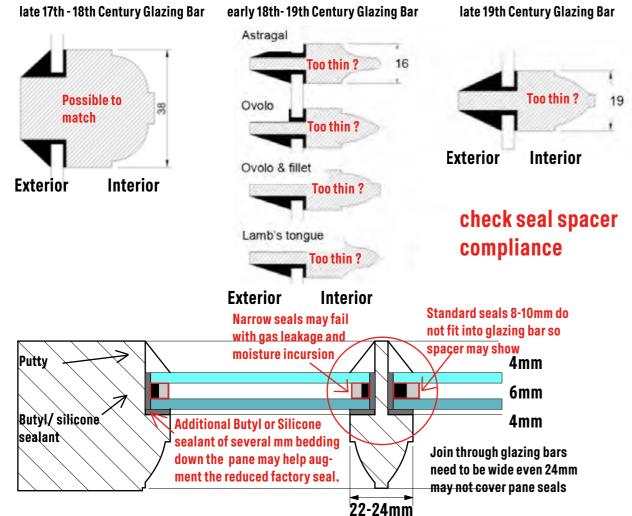
Slim-Profile Detail Plan Section Timber Sash

36/34 Cross Street wide glazing bars which could take sealed double glazed units mounted into this original timber sash, or see page 88 vacuum glass.

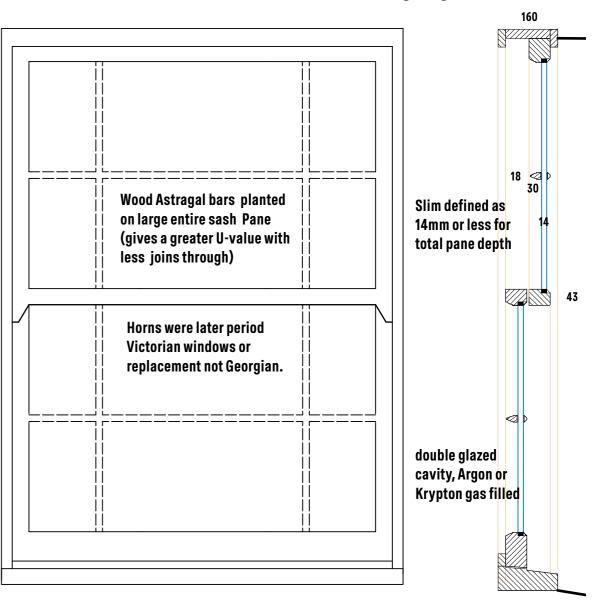
2.5X less heat loss than single glazed window at U-value 5 W/m²k Whole window U-value of 1.9 W/m²K, 2021 Bldg Reg is 1.4W/m²k

details from Manufacturer Mumford&Wood

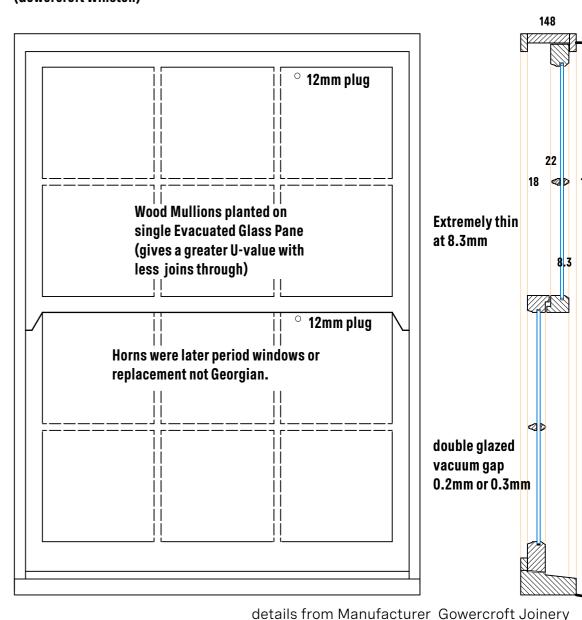
Whole window U-value of 1.2 W/m²K surpasses Building regs. (Gowercroft Winston)

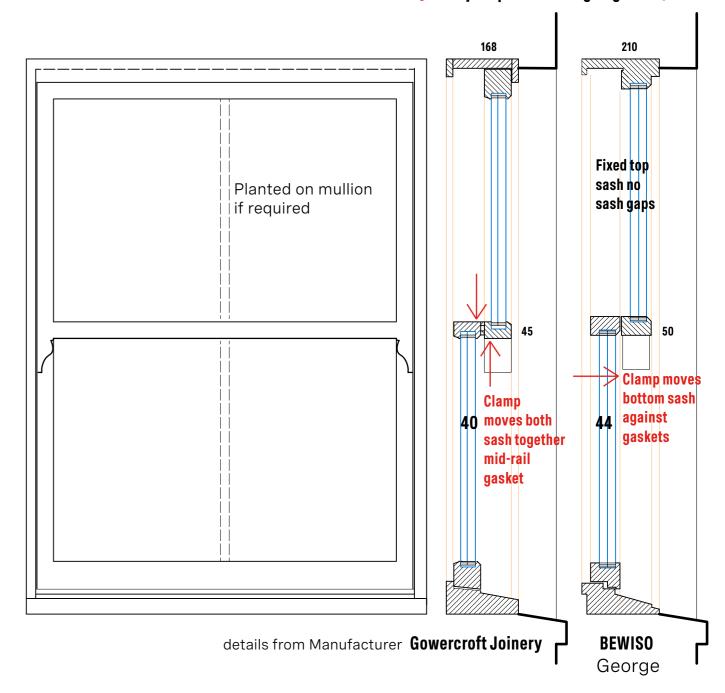
Whole window U-values of 1.0-1.3 w/m²K, surpass Building Regs 1.4w/m²k

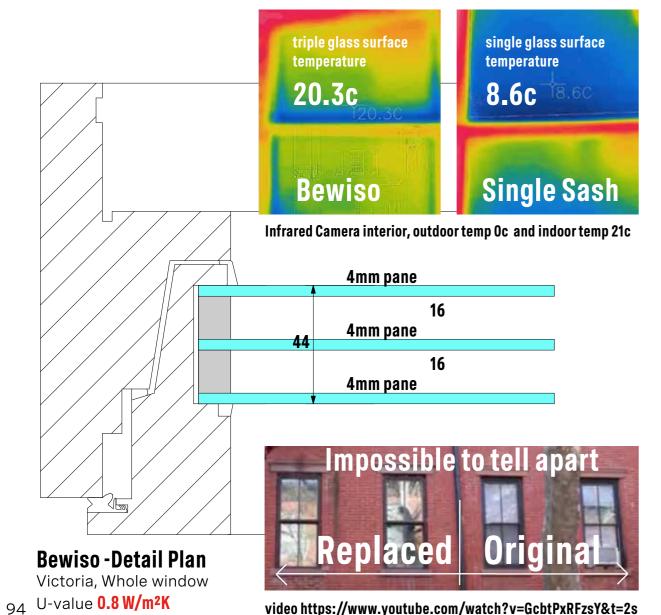
Simulated Hung Sash

Exterior - Simulated Hung sash Bewiso Victoria -cert. 0.8w/m2K

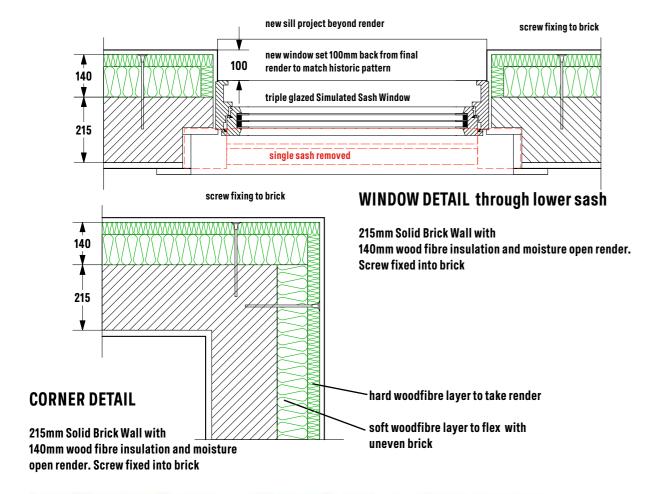
Existing Wall Upgrade **0.30w/m²K U-value**. Building Regs 2021, 140mm woodfibre Better approach if there is space 0.15-0.20 w/m²K U-value, 240mm+-

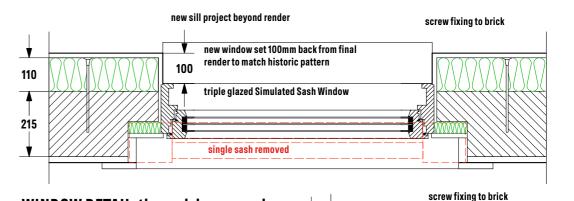
WINDOW DETAIL through lower sash

Better approach if there is space 0.15-0.20 w/m²K U-value, 220mm +-

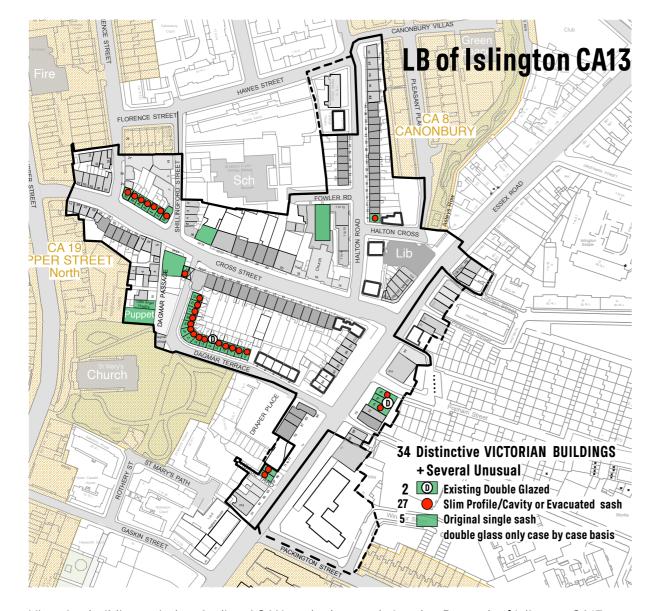
Victorian buildings window Audit - ACAN worked example London Borough of Islington CA13

Several Victorian mansion buildings have intact sash which should be retained with new evacuated double glass panes inserted into this original sash on a case by case basis.

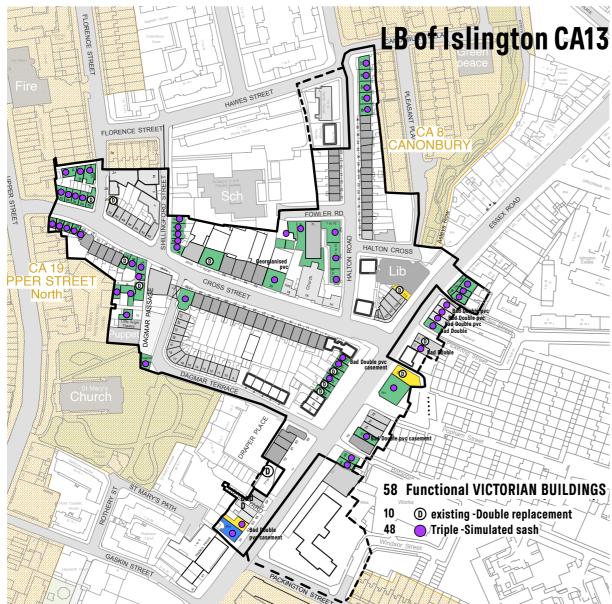
Victorian Triple window Audit - ACAN worked example London Borough of Islington CA13

Triple glazed simulated hung sash designed for conservation areas
